Walking Audit Report

City of Hallandale Beach

Dixie Highway/N/S 21st Avenue/NE/SE 1st Avenue
from County Line Road
to Sheridan Street

June 2019

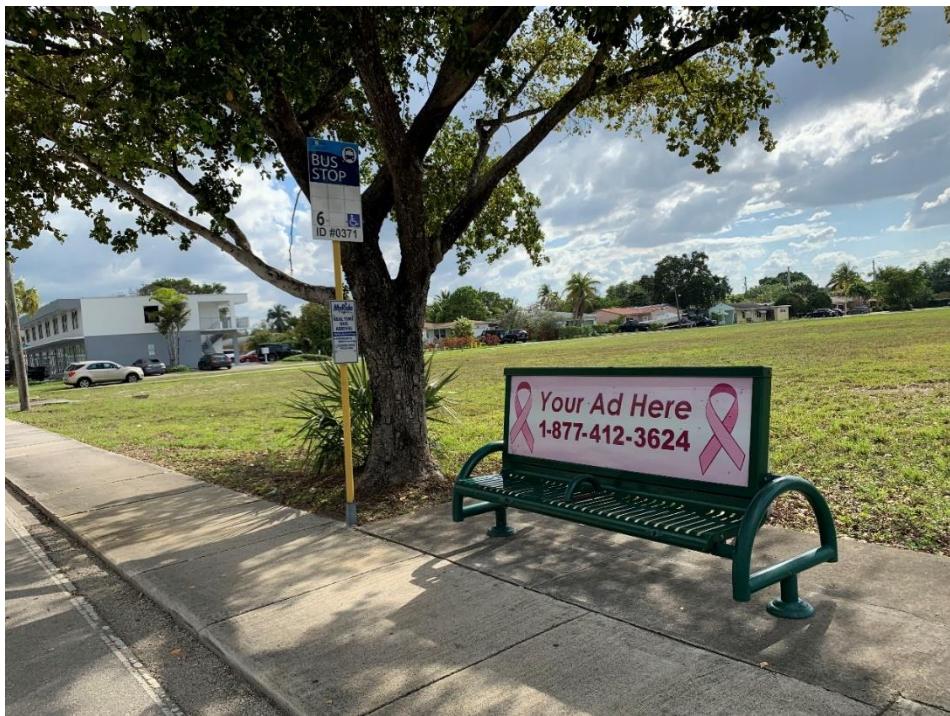
BCT Route 6 Bus Stop ID# 0371 with seating on Dixie Highway south of SW 3rd Street

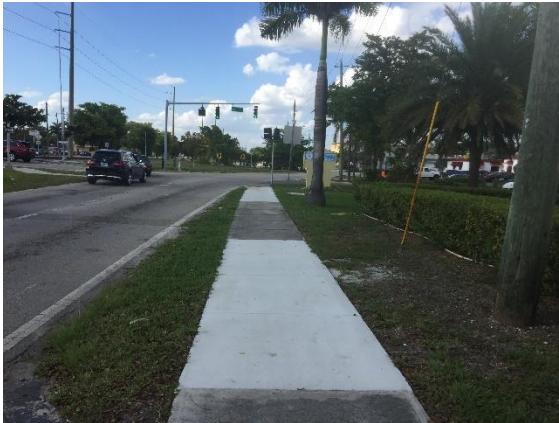
Sidewalk on the east side of SE 1st Avenue with a buffer between the sidewalk and curb, also known as a furnishing zone.

Provide continuous furnishing zone used for landscape and street trees along Dixie Highway and SE 1st Avenue to enable active public space.

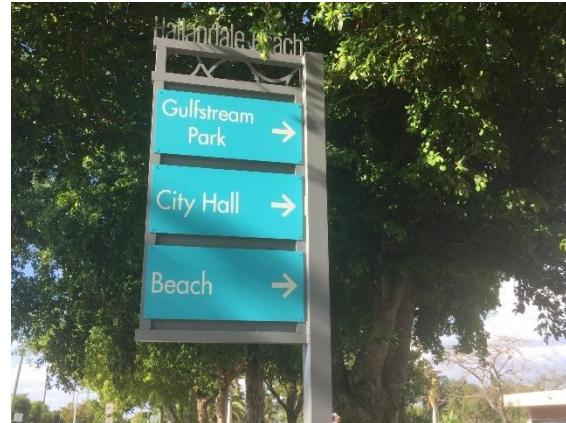
Wayfinding signage to navigate people from place to place is found along the corridor.

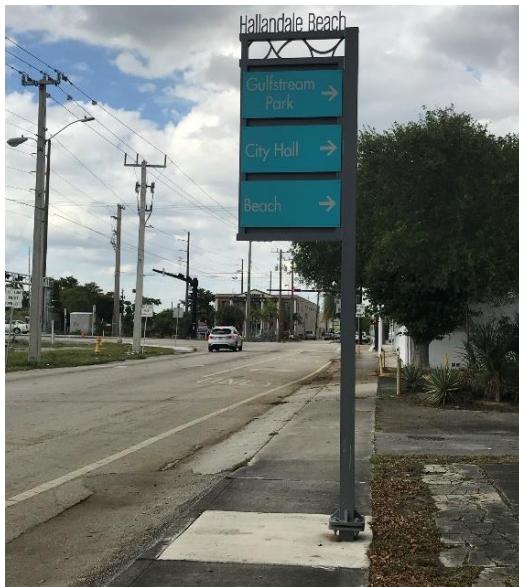
The wayfinding signage is being held with a breakaway base support. Breakaway base support can reduce damage to cars and occupants.

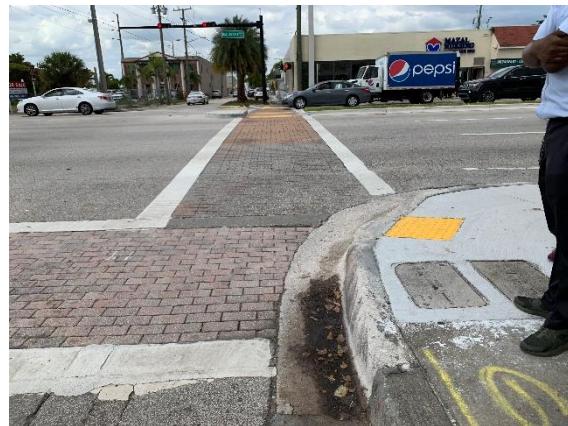
Decorative crosswalk markings exist at Dixie Highway and SE 1st Avenue at Hallandale Beach Boulevard.

- Stamped asphalt on the eastern side of SE 1st Avenue and Hallandale Beach Boulevard
- Concrete pavers on the southern side of SE 1st Avenue and Hallandale Beach Boulevard
- Stamped asphalt on the western side of Dixie Highway and Hallandale Beach Boulevard

Provide stamped asphalt crosswalk on all approaches and detectable warnings on curb ramps at the following signalized intersections.

- Dixie Highway and SE 1st Avenue at SR-858/Hallandale Beach Boulevard
- Dixie Highway and SE 1st at SW/SE 3rd Street
- Dixie Highway and SE 1st at NE 215th Street

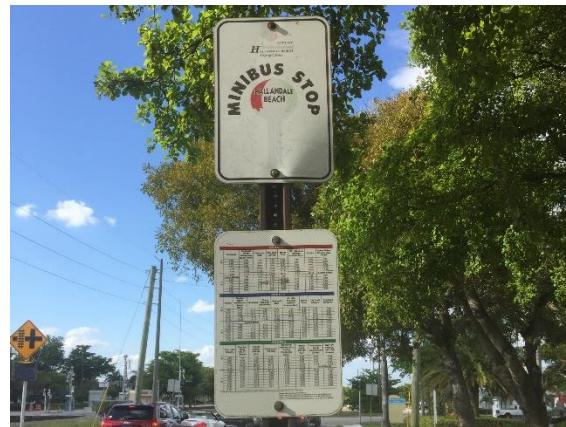
Remove the old signage that references "MINIBUS STOP" along SE 1st Avenue located between SE 4th Street and SE 3rd Street.

- Remove the old signage that references “MINIBUS STOP” along SE 1st Avenue located between SE 4th Street and SE 3rd Street.
- Replace and install MUTCD R10-3i (Pedestrian Signs and Plaques) to accurately depict “PUSH BUTTON TO CROSS” and include roadway name.
- The YMCA at the southeast corner of SE 1st Avenue and SE 5th Street is under construction and holds opportunity to incorporate Complete Streets elements into the corridor. Coordination with the YMCA is essential.
- Potentially explore stationing unoccupied police vehicles along the corridor to enforce speed and a traffic calming solution.
- Maintain the landscape throughout the corridor to prevent endangering pedestrians and blocking the view of pedestrian signs. As well as ensuring rubbish is picked-up
- Re-orient the mis-aligned pedestrian signals at the intersection of SE 1st Avenue and SE 3rd Street.

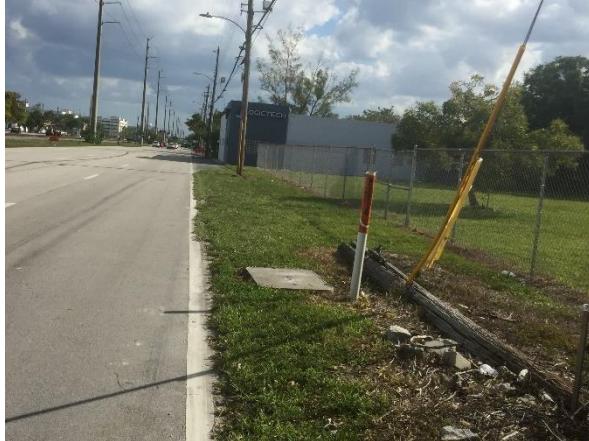
Lack of sidewalk facilities in several areas of the corridor such as Dixie Highway from Miami-Dade/Broward County Line to SW 10th Street and Dixie Highway from SW 9th Street to SW 5th Street.

Provide a continuous sidewalk with trees adjacent to facility to add shade.

- Dixie Highway from Miami-Dade/Broward County Line to SW 10th Street
- Dixie Highway from SW 9th Street to SW 5th Street
- Dixie Highway from NW 2nd Street to Pembroke Road
- SE 1st Avenue from NE 7th Street to Pembroke Road

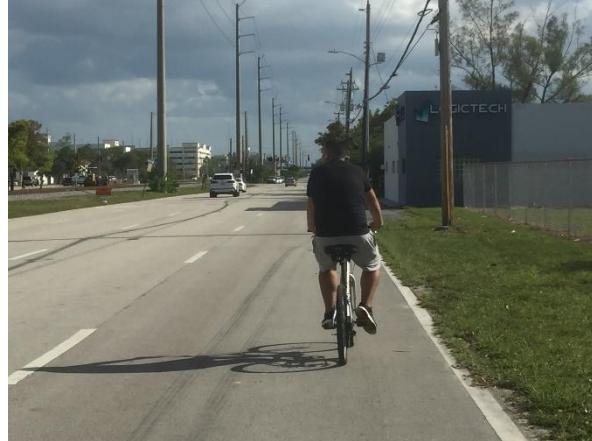
There is a lack of bicycle facilities throughout the corridor resulting in bicyclists riding in the travel lanes alongside motor vehicles.

Provide a green marked bicycle lane.

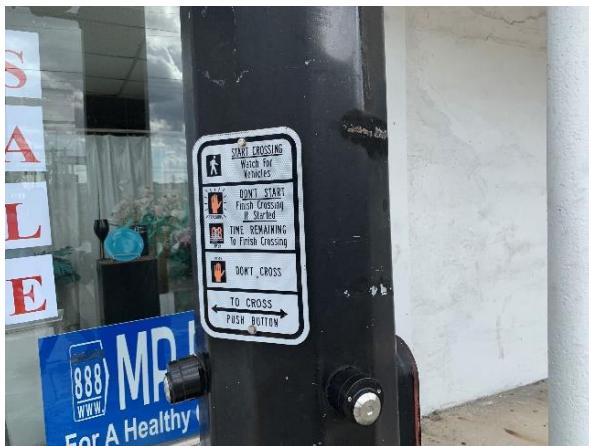
The pedestrian crossing sign does not correspond with MUTCD R10-3e (Pedestrian Signs and Plaques).

Replace and install MUTCD R10-3i (Pedestrian Signs and Plaques) to accurately depict "PUSH BUTTON TO CROSS" and include roadway name.

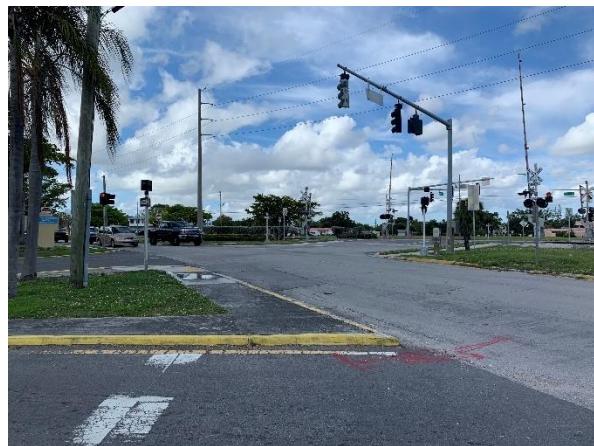
Unmarked crosswalk at a signalized intersection of Dixie Highway/SE 1st Avenue and SW/SE 3rd Street.

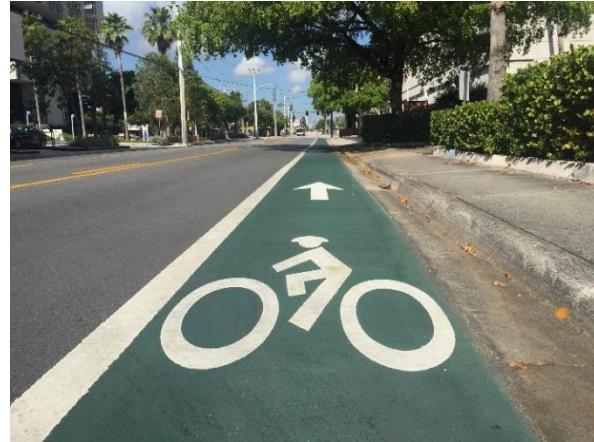
This photo is an example in Fort Lauderdale.

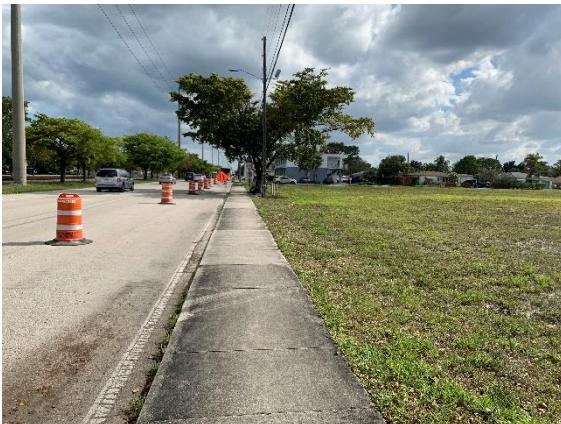
There is a vacant parcel on the west side of Dixie Highway between SW 4th Street and SW 3rd Street for potential redevelopment opportunity.

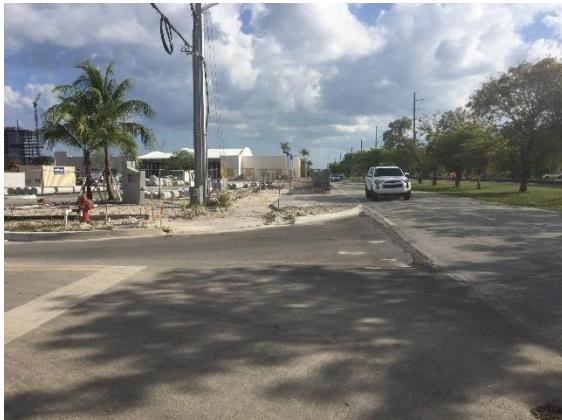
The YMCA at the southeast corner of SE 1st Avenue and SE 5th Street is under construction and holds opportunity to incorporate Complete Streets elements into the corridor.

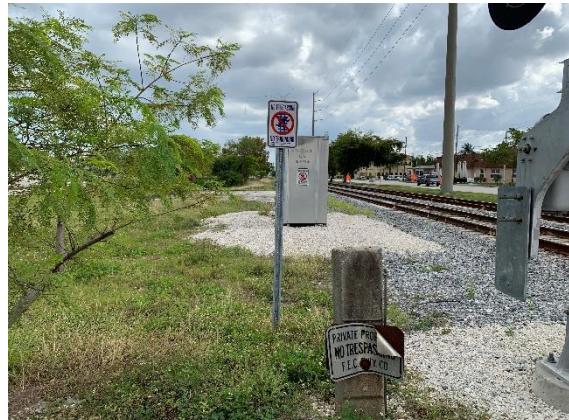
Existing "PRIVATE PROPERTY NO TRESPASSING F.E.C. RWY. CO" and "NO TRESPASSING" signage. The existing signage raises awareness to prohibit walking or playing on railroad tracks or the right-of-way on either side of the tracks as trespassing. To further promote safety; installing a fence along the FEC corridor will physically prohibit people crossing the tracks.

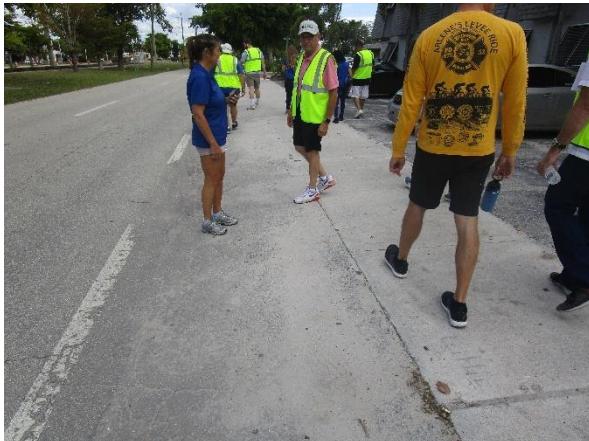
Along SE 1st Avenue, there is nearly a four-foot buffer between the sidewalk and the travel lanes. A shared-use path can potentially be included in this corridor.

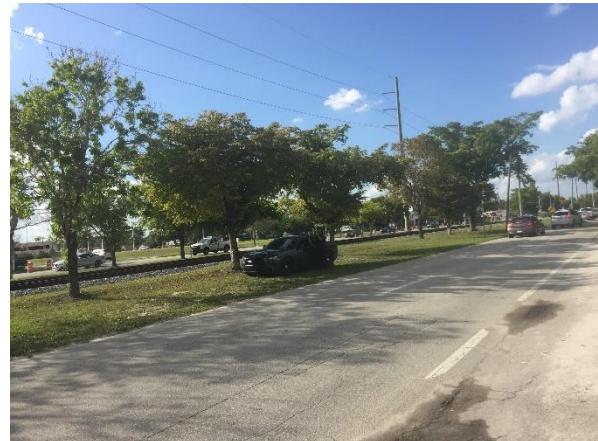
A police officer enforcing speed along SE 1st Avenue. Potentially explore stationing unoccupied police vehicles along the corridor to enforce speed and a traffic calming solution.

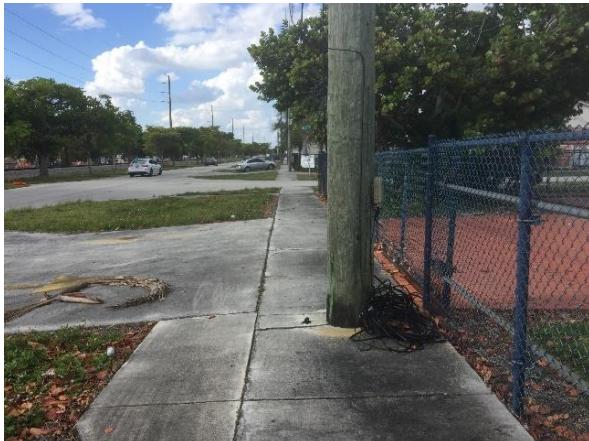
Street fixtures are within the sidewalk, which prevents a clear pedestrian zone and utility cords have not been properly placed.

Relocate fixtures from pedestrian zones or if unable, provide additional space to maintain ADA compliant width.

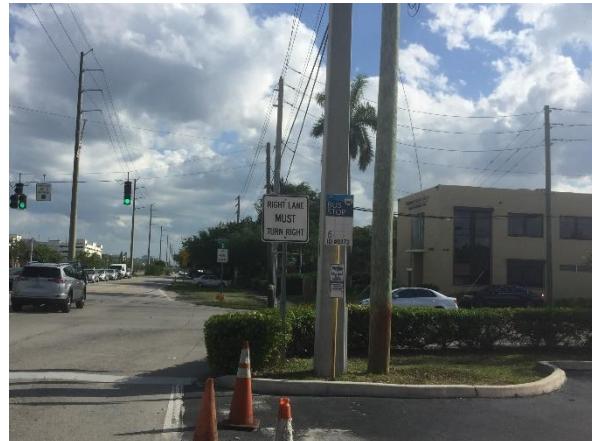
Route 6 – Stop ID #0373 does not have proper bus stop amenities such as ADA landing pad/passenger waiting area, bench, shelter, trash receptacle, lighting & etc.

Provide a clear unobstructed 5'x8' landing pad and provide amenities such as bench, shelter, trash receptacle, bike racks, and a handrail at the following stops.

- Route 6 – Stop ID# 0373
- Route 6 – Stop ID# 3537
- Route 6 – Stop ID# 0372
- Route 6 – Stop ID# 2426
- Route 6 – Stop ID# 0371
- Route 6 – Stop ID# 3087

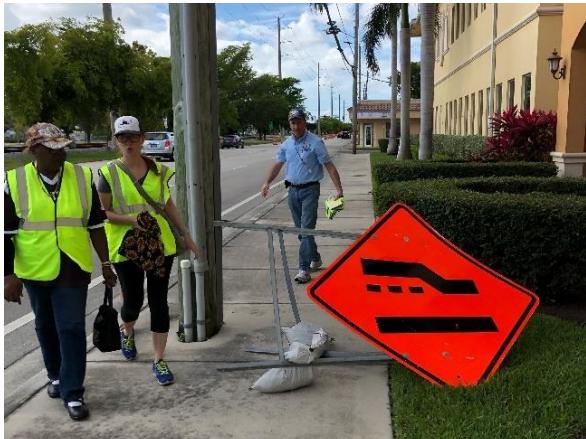
Construction signage knocked down in front of 134 S Dixie Highway.

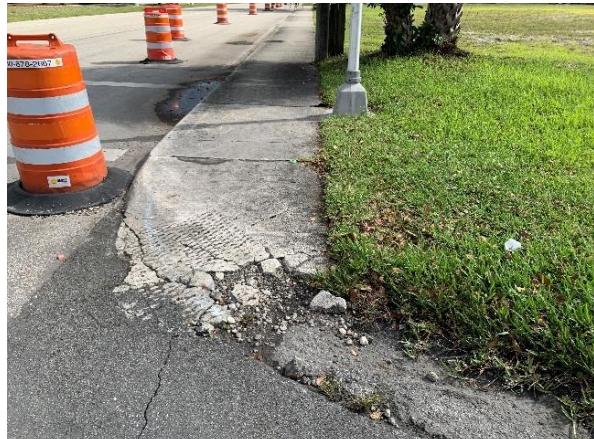
Sidewalk cracking which causes trip hazards.

Evaluate the condition of sidewalks intersecting driveways and sidewalk condition to ensure a cross slope of 1% (2% maximum) to meet ADA standards.

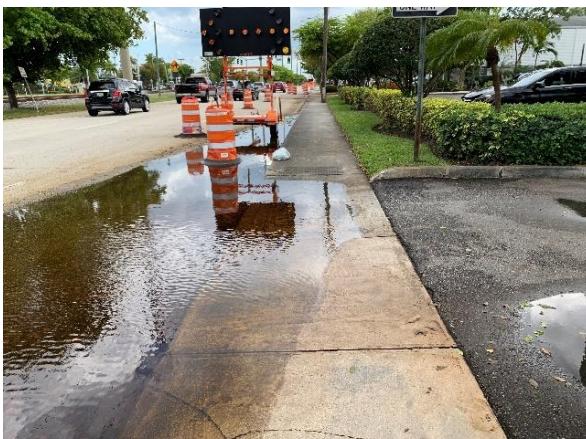
Drainage issues along Dixie Highway and SE 1st Avenue, which causes excessive water over sidewalks.

- Provide additional wayfinding signage for prominent destinations along the corridor such as Peter Bluesten Park and YMCA.
- Insert a catch basin which includes an inlet, riser, and piping to prevent drainage issues.
- Provide continuous furnishing zone used for landscape and street trees along Dixie Highway and SE 1st Avenue to enable active public space.
- Provide stamped asphalt crosswalk on all approaches and detectable warnings on curb ramps at the following signalized intersections.
 - Dixie Highway and SE 1st Avenue at SR-858/Hallandale Beach Boulevard
 - Dixie Highway and SE 1st at SW/SE 3rd Street

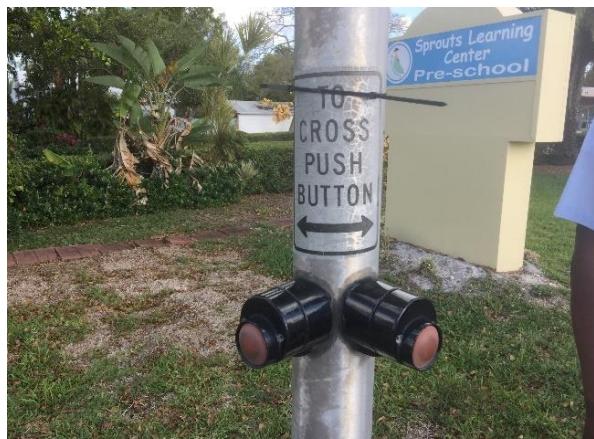
Outdated pedestrian pushbutton at Sprouts Learning Center Pre-School located at the southeast corner of SE 1st Avenue and SE 3rd Street.

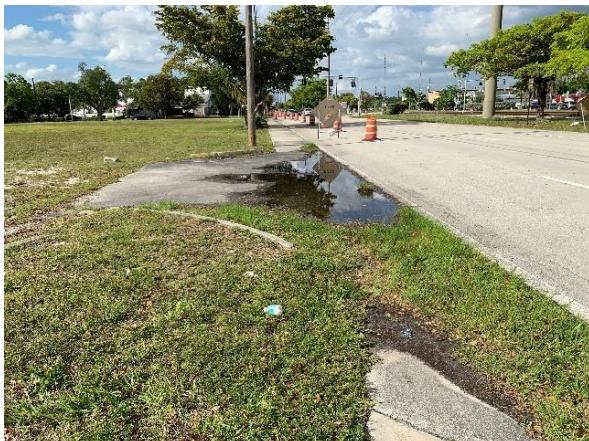
The vacant parcel/former development on the west side of Dixie Highway between SW 4th Street and SW 3rd Street driveway is unmaintained, which causes discontinuation in the sidewalk with overgrown grass and flooding.

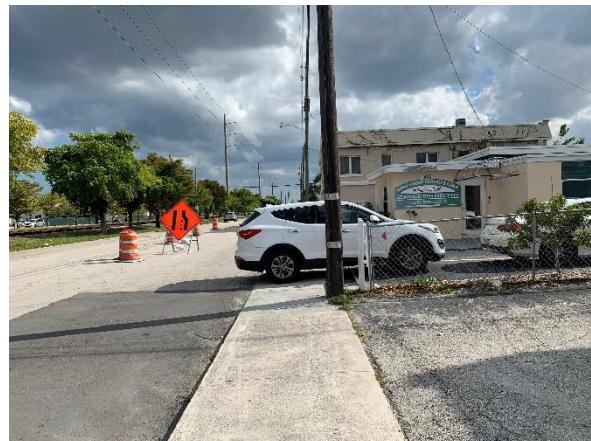
The sidewalk is treated as a driveway and additional parking which blocks the sidewalk for pedestrians.

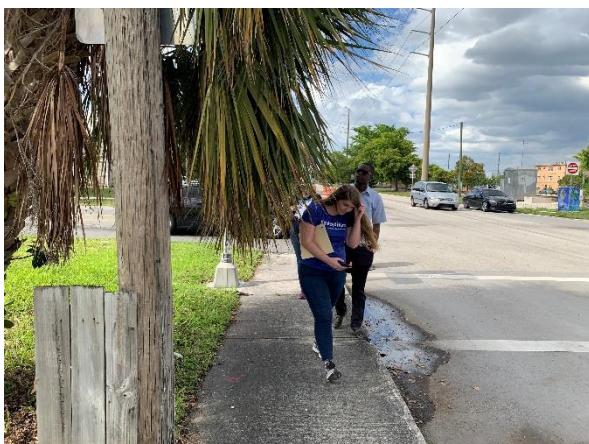
Overgrown trees endanger pedestrians and block the view of pedestrian signs.

Maintain the landscape throughout the corridor to prevent endangering pedestrians and blocking the view of pedestrian signs. As well as ensuring rubbish is picked-up.

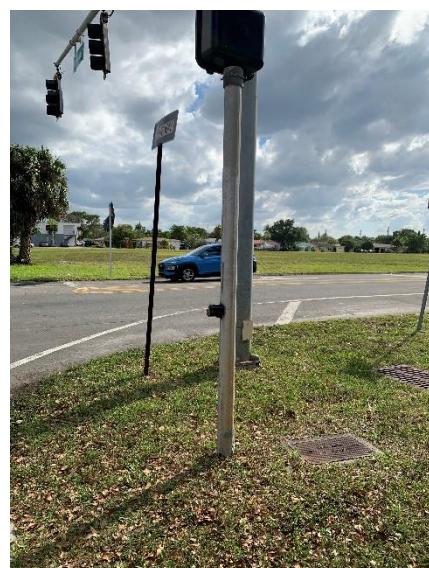
The pedestrian signal and pedestrian pushbutton is located in the northwest corner of Dixie Highway and SE 3rd Street without providing a clear and accessible path for non-motorized users.

Provide pedestrian access to the pedestrian signal and pedestrian pushbutton as well as ensuring adequate distance to curb ramp located in the northwest corner of Dixie Highway and SE 3rd Street.

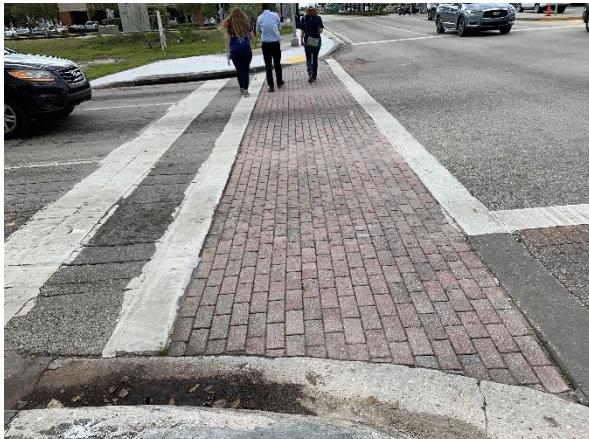
Concrete pavers used for crosswalks may cause rigid body uplift or settlement.

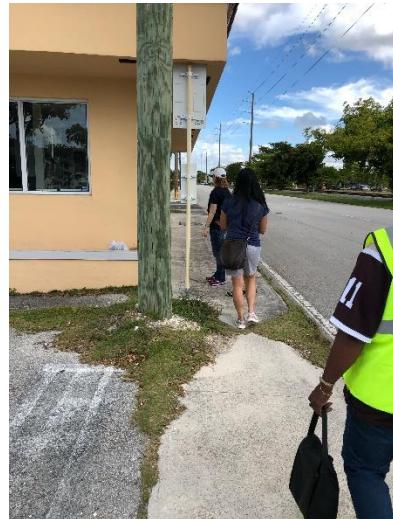
Unmaintained landscape encroaches the sidewalk facilities.

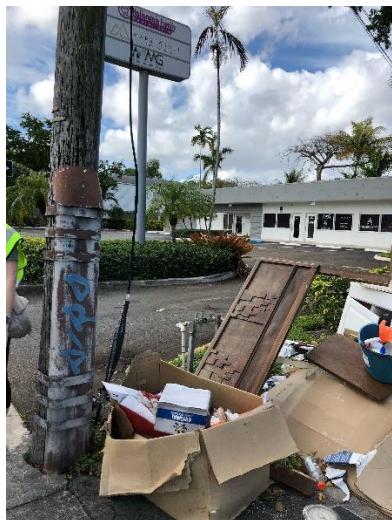
Rubbish is located near 206 Dixie Highway which may detract users from the corridor.

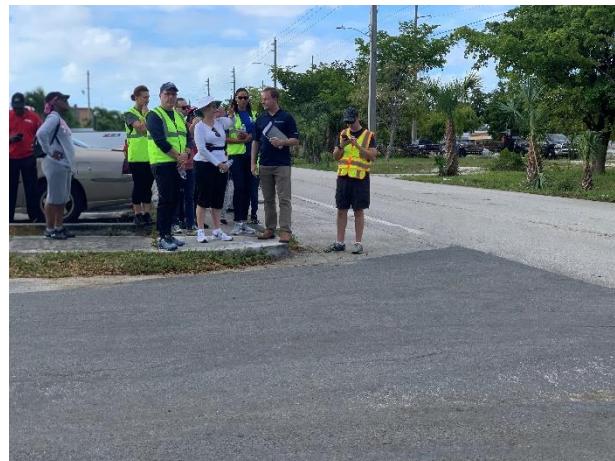
The pedestrian crossing along SE 1st Avenue and SE 1st Street does not have curb ramps.

- Route 6 – Stop ID# 3950
- Provide a curb ramp at SE 1st Avenue and SE 1st Street to provide an accessible route for all users.

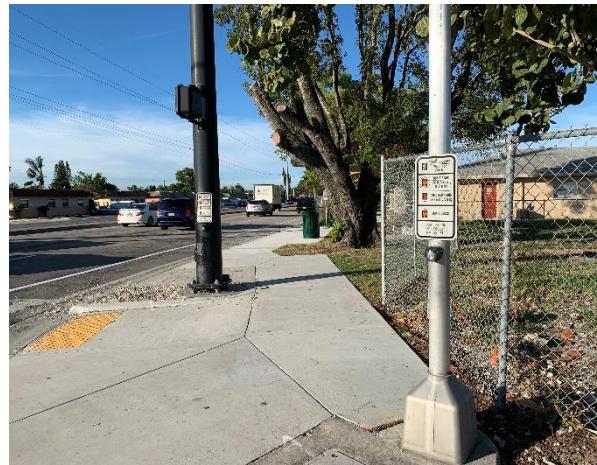
This photo is an example along NW 31st Avenue, Lauderdale Lakes.

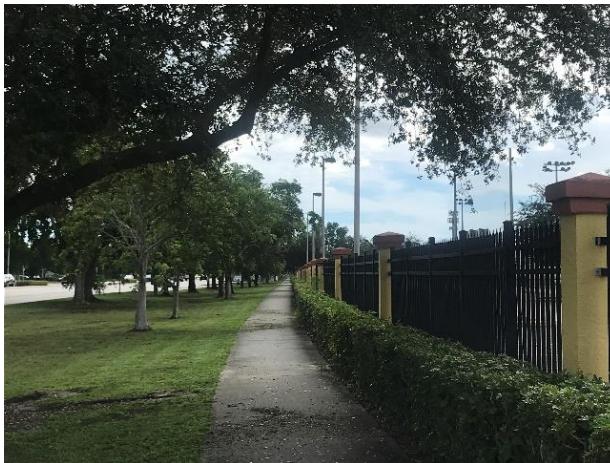
This photo is an example along Oakland Park Boulevard, Lauderhill.
