Walking Audit Report

City of North Lauderdale and City of Margate

Southgate Boulevard from
SW 81st Avenue to SR 7/US 441

July 2019

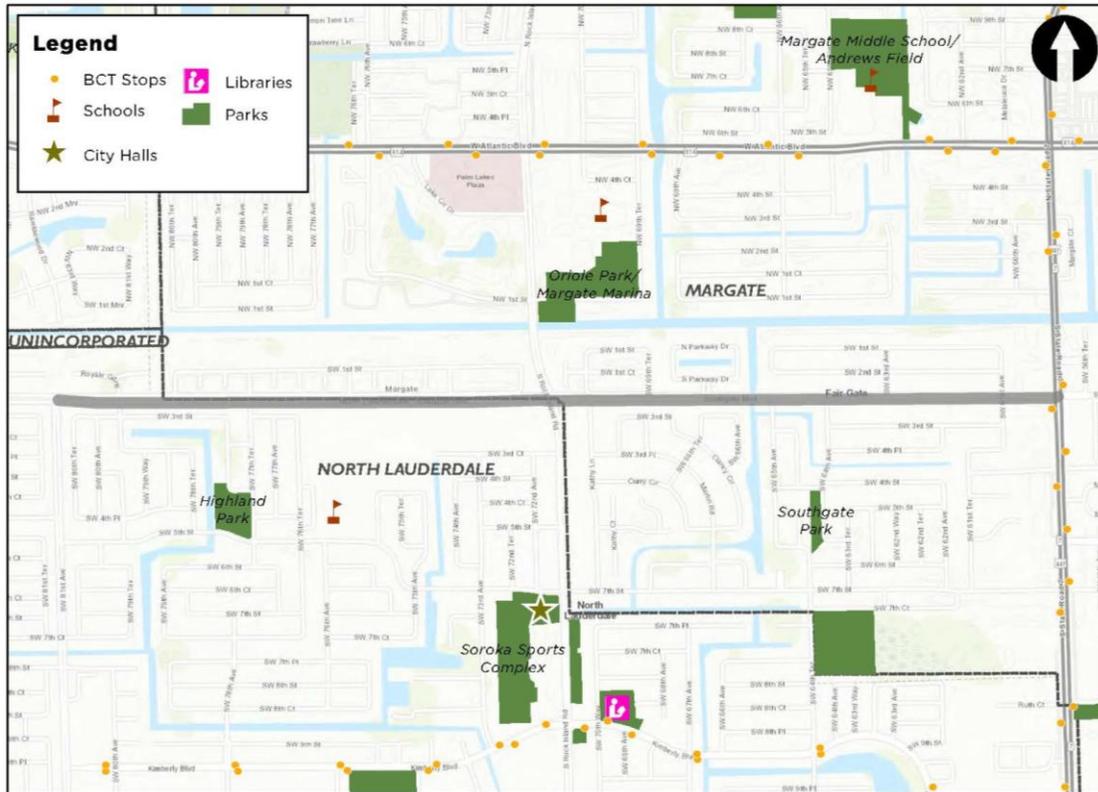
Figure 1. Study Corridor

The corridor has a speed limit that ranges from 30-40 miles per hour (MPH); west of SW 63rd Avenue is 40 MPH and east of SW 63rd Avenue is 30 MPH and the 2018 Average Annual Daily Traffic (AADT) ranges from 21,200-30,500. The functional classification for the roadway is an urban minor arterial. The 4-lane divided roadway provides access for non-motorized users along the north and south sides of Southgate Boulevard but has significant gaps along the northside of the network. The sidewalk width is 5 feet.

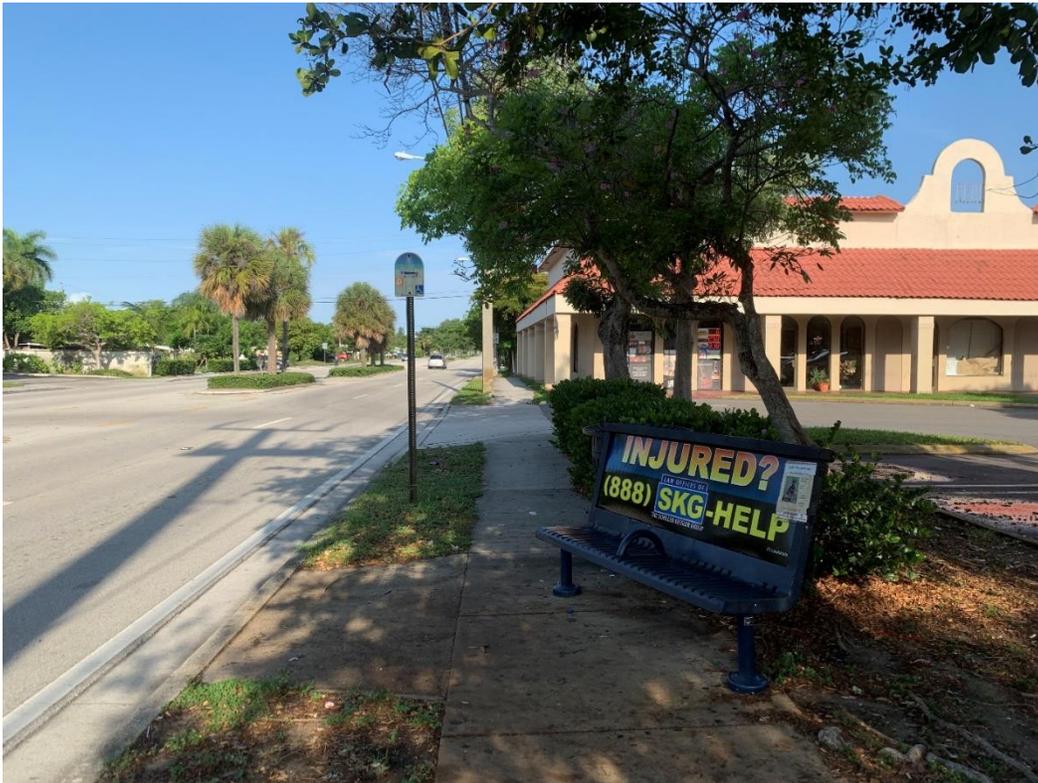
Margate Inner-City Transit Route D bus stop with seating on Southgate Boulevard west of US-441/SR-7

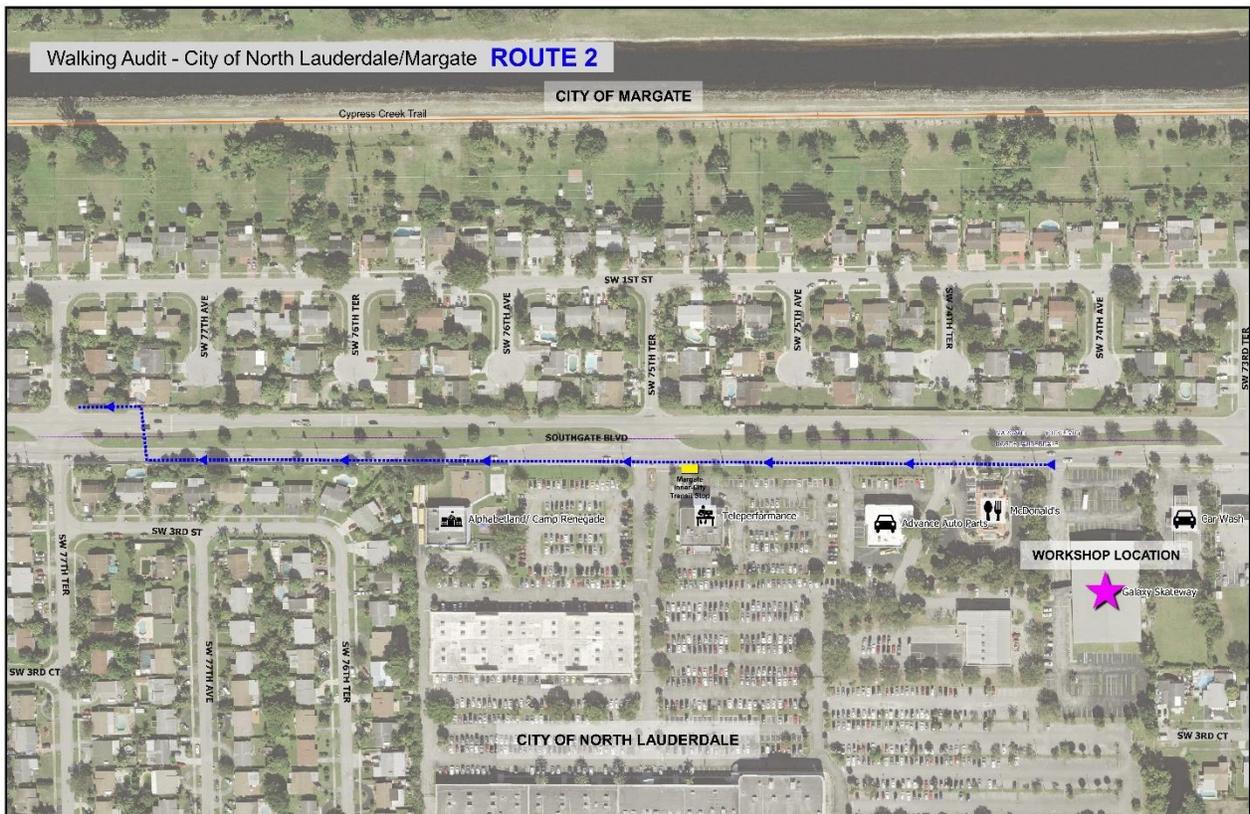
Figure 5. Walking Audit Route 2 – destinations

Shown in Figure 5 are the different destinations along Route 2. The northern side of Southgate Boulevard is heavily residential. The southern side of Southgate Boulevard includes an auto repair shop, child car facilities, major employers such as Teleperformance, fast food restaurant, Galaxy Skateway, and residential homes. Appendix A includes the aerial maps shown in its original size.

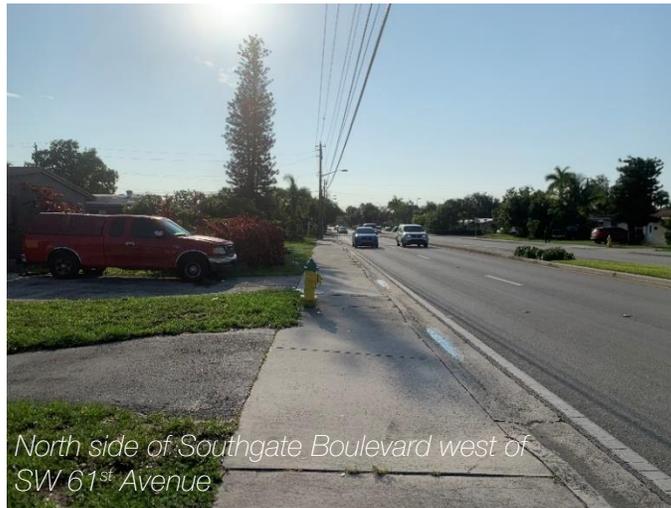
The top three cross-section elements that are present but need to be upgraded are: sidewalk, buffer between the sidewalk and edge of pavement, and bus stop seating. There is no sidewalk along the north side of Southgate Boulevard from SW 79th Avenue to SW 69th Terrace, however in some areas sidewalk is provided on the adjacent residential street. There is an infrequent buffer between the sidewalk and edge of pavement along the south side of Southgate Boulevard. The Margate Inner-City Transit Route D runs along Southgate Boulevard.

North side of Southgate Boulevard west of SW 61st Avenue

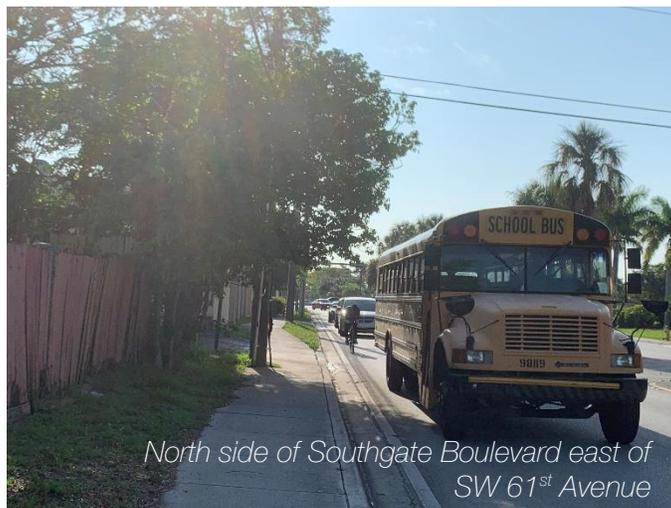
The top three cross-section elements that currently do not exist along the study corridor but are needed to be included are: bike lane, buffer between the sidewalk and edge of pavement, and bus stop seating.

North side of Southgate Boulevard east of SW 61st Avenue

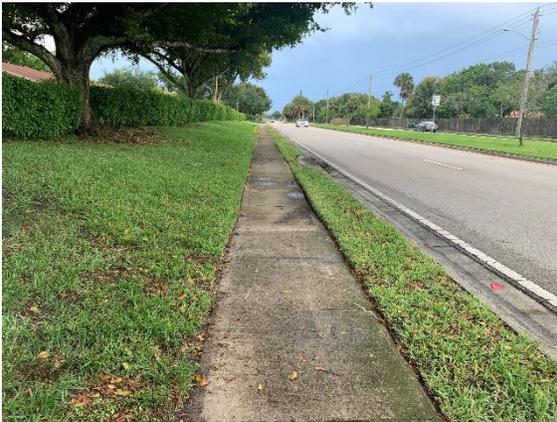
Sidewalk on the north side of Southgate Boulevard with a buffer between the sidewalk and curb, also known as a furnishing zone.

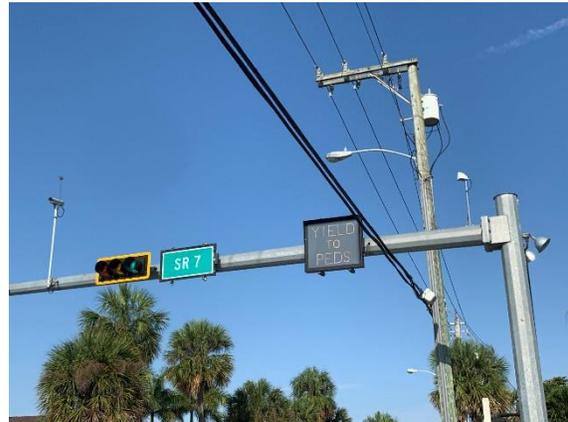
Variable message sign for NO TURN ON RED/YIELD TO PEDS on all four legs at the intersection of Southgate Boulevard and SR-7/US-441.

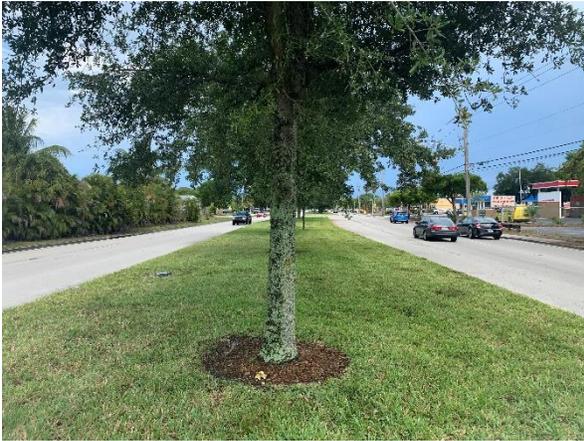
There is a 30- to 40-foot median dividing the east and westbound lanes of Southgate Boulevard, providing landscaping and beautification of the corridor.

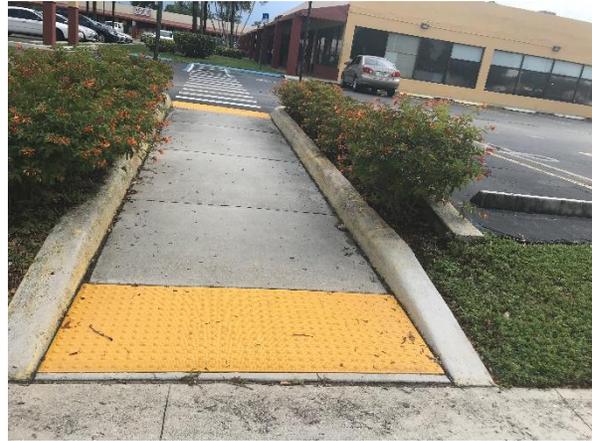
Several businesses along the corridor provide pedestrian access with ADA compliant detectable warnings and ramps. This access point leads to the Presidential Plaza shopping center.

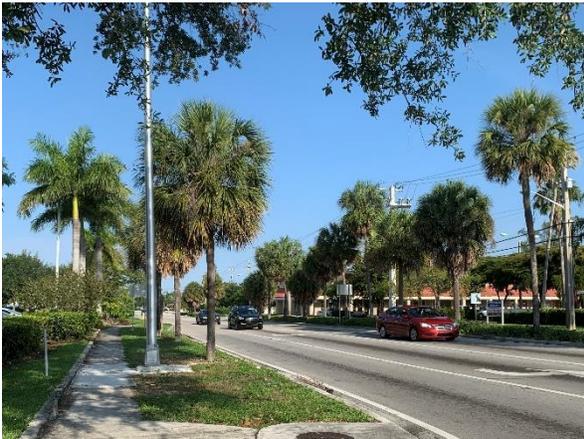
Along the south side of Southgate Boulevard near SR-7/US-441, there are some trees that provide shade.

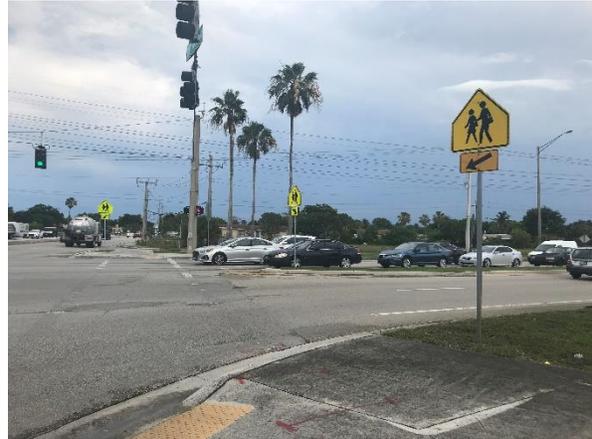
Pedestrian signage is present in most areas where pedestrians may cross vehicular traffic, including intersections and driveways.

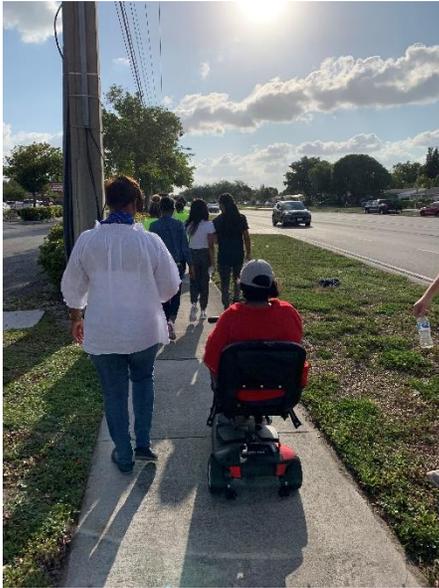
The sidewalk width is 5 feet on the southside of Southgate Boulevard from SW 73rd Terrace to Rock Island Road.

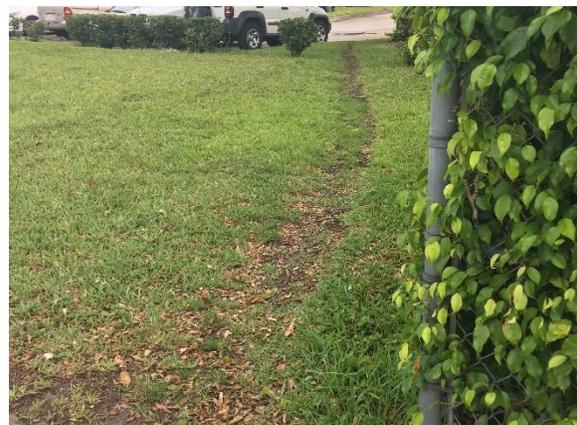
Desire path on the south side of Southgate Boulevard west of 75th Terrace showing pedestrian access point to shopping center. Provide a paved pedestrian access point at this location.

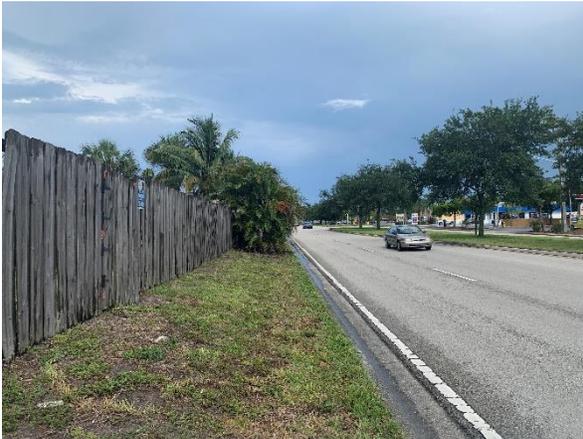
Lack of sidewalk facilities along the north side of the corridor from SW 79th Avenue to SW 73rd Terrace.

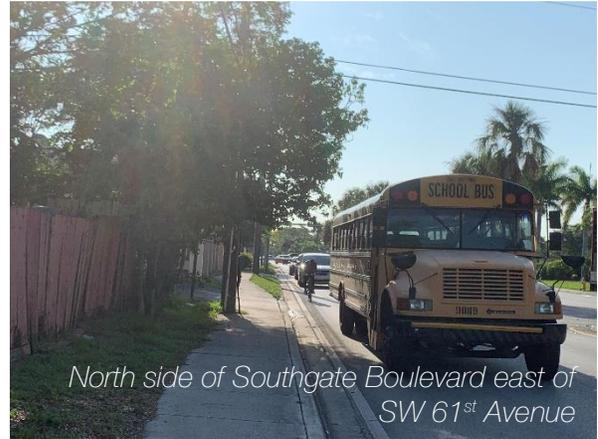
There is a lack of bicycle facilities throughout the corridor resulting in bicyclists riding in the travel lanes alongside motor vehicles.

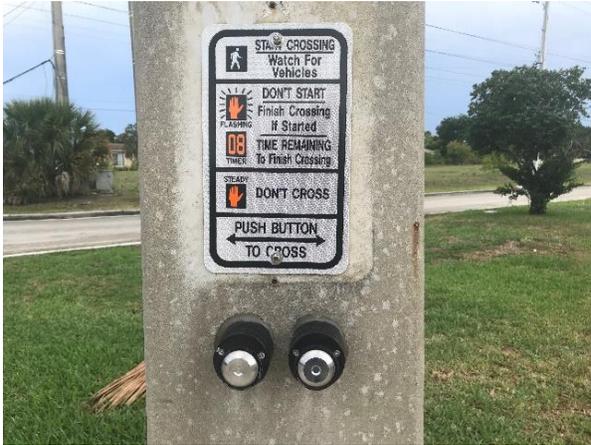
Pedestrian push buttons are not oriented toward desired crossing street and signage is not provided for each approach.

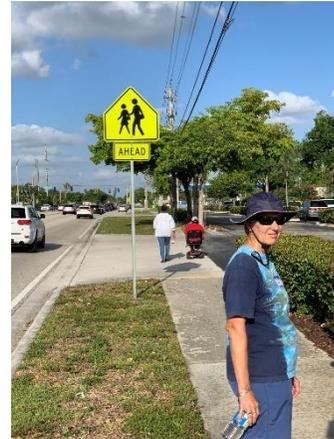
The driveway apron goes through the sidewalk/pedestrian crossing at the Presidential Plaza.

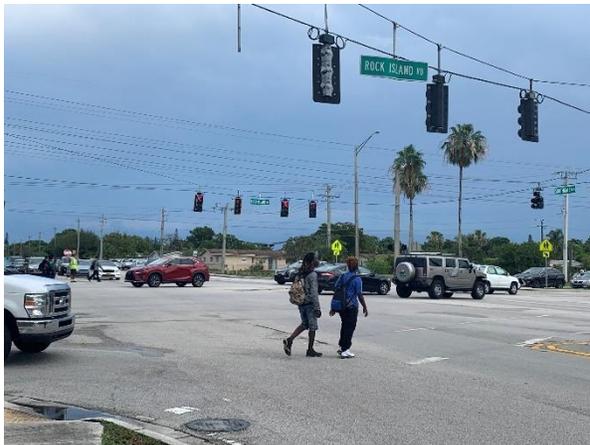
The marked crosswalk pavement markings at Southgate Boulevard and Rock Island Road/SW 71st Avenue is faded.

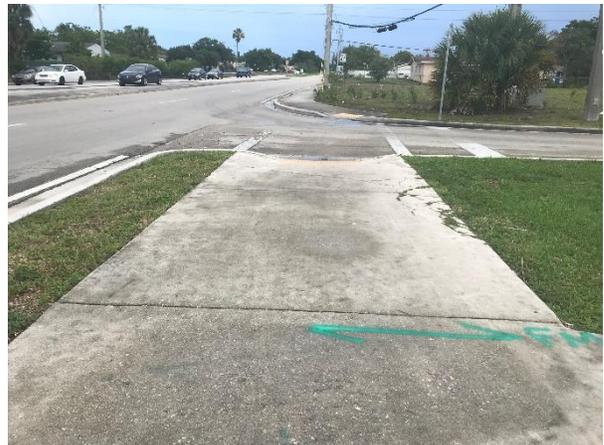
The pork chop island at the southeast corner of Southgate Boulevard and Rock Island Road/SW 71st Avenue forces pedestrians to cross a lane of right-turning vehicles with no pedestrian signal.

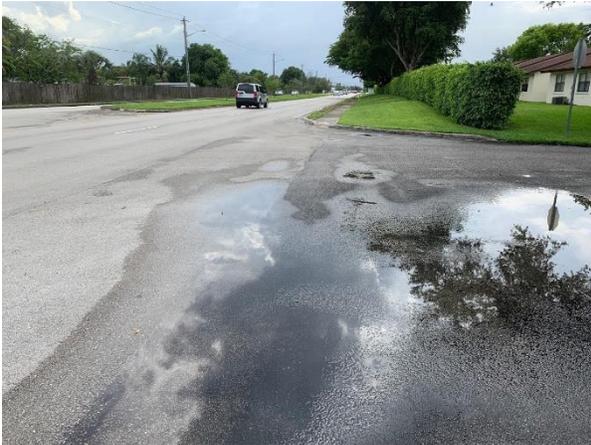
Parkway Drive, the driveway to the residential complex hold small bird-baths.

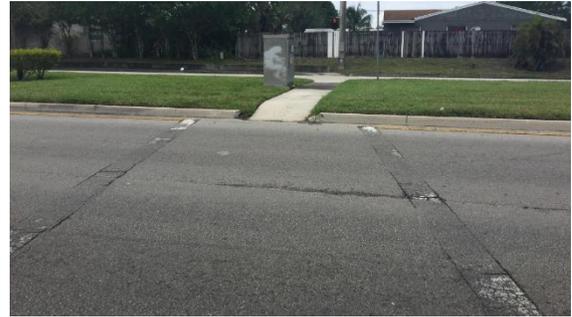
The mid-block crossing along Southgate Boulevard east of SW 77th Terrace marked crosswalk pavement markings is faded and no detectable warnings.

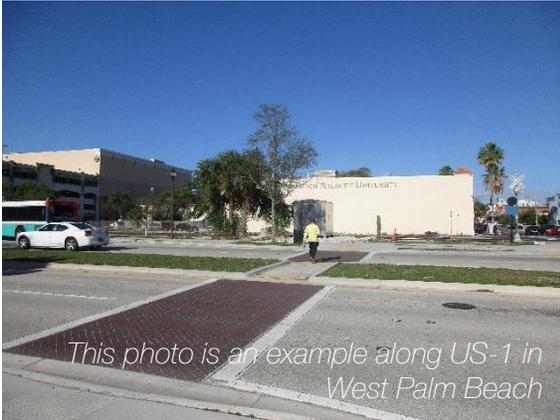
This photo is an example along US-1 in West Palm Beach

Further study is needed in providing a mid-block signed and marked crosswalk along Southgate Boulevard at SW 73rd Terrace, connecting the residential land use to the north with the commercial land use to the south.

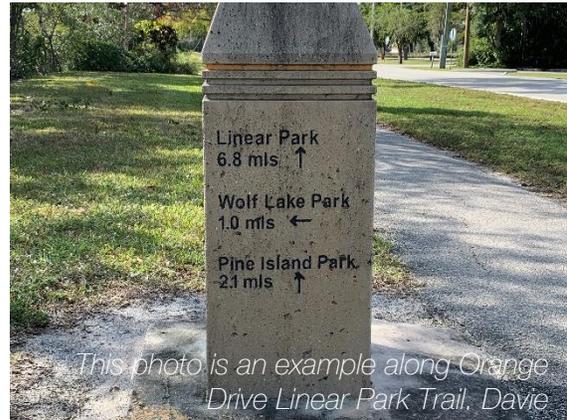
This photo is an example along Orange Drive Linear Park Trail, Davie

Provide wayfinding signage at SW 81st Avenue, Rock Island Road, and SR-7/US-441 to notify users about the C-14 Canal/Cypress Creek Greenway, which is north of Southgate Boulevard.

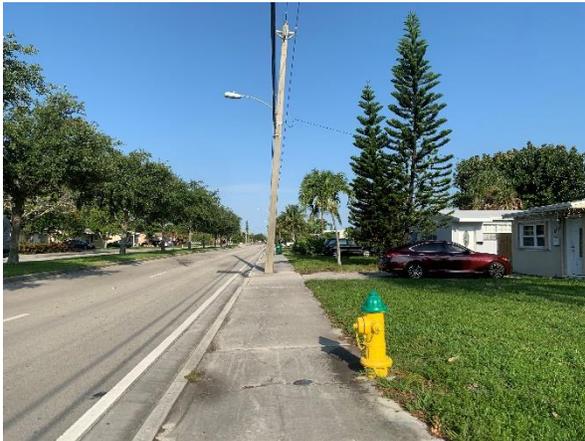
Street fixtures are within the sidewalk, which prevents a clear pedestrian zone.

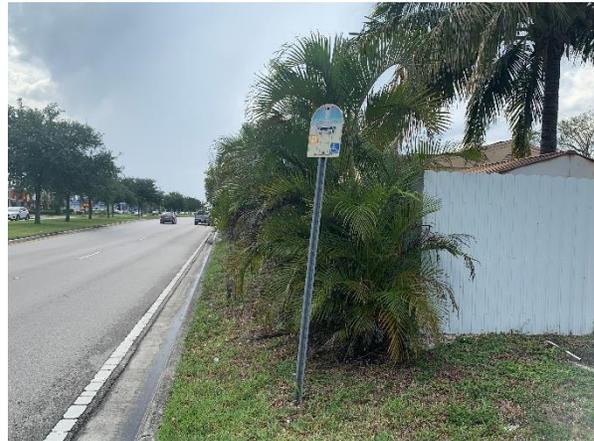
Route D stop located west of SW 73rd Terrace does not have proper bus stop amenities such as ADA landing pad/passenger waiting area, bench, shelter, trash receptacle, lighting & etc.

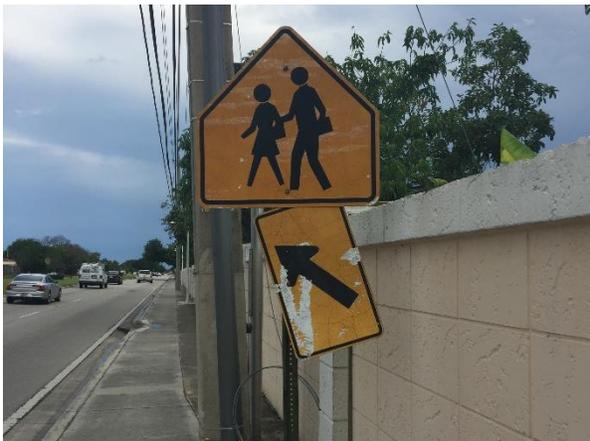
Pedestrian crossing signage damaged located at mid-block crossing along Southgate Boulevard east of SW 77th Terrace.

- Replace damaged pedestrian crossing signage located at mid-block crossing along Southgate Boulevard east of SW 77th Terrace.
- Maintain the landscape throughout the corridor to prevent blocking pedestrian space, improve visibility, and reduce blocking the view of pedestrian signs.

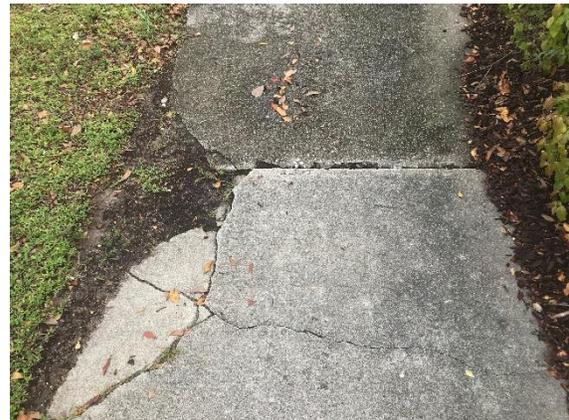
Sidewalk cracking which causes trip hazards.

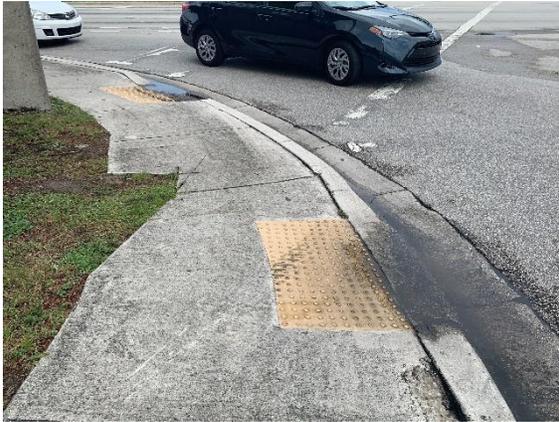
Drainage issues at the intersection of Southgate Boulevard and Rock Island Road/SW 71st Avenue which causes pooling of water at curb ramps.

- Evaluate the condition of sidewalks intersecting driveways and sidewalk condition to ensure a cross slope of 1% (2% maximum) to meet ADA standards.
- Insert a catch basin which includes an inlet, riser, and piping to prevent drainage issues.

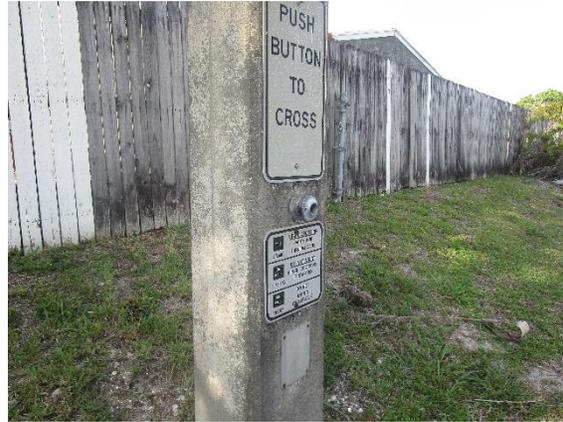
Outdated pedestrian pushbutton at mid-block crossing along Southgate Boulevard east of SW 77th Terrace.

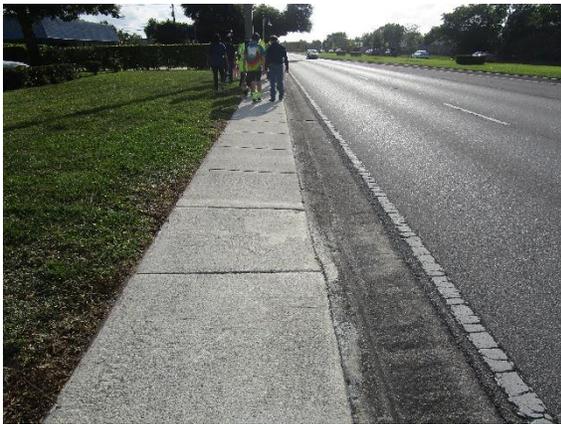
Curb cut for former driveway west of SW 75th Terrace is unnecessary and should be reconstructed.

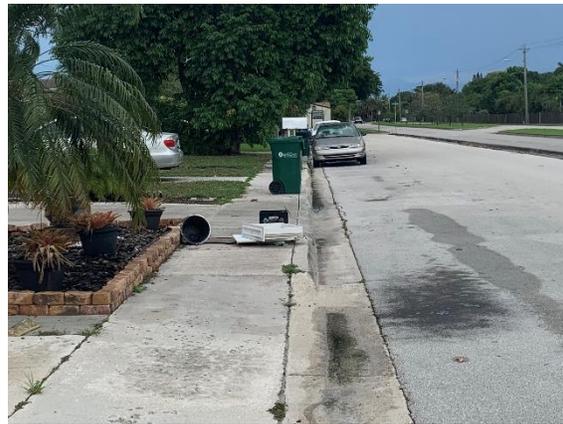
The sidewalk on the north side of Southgate Boulevard west of SW 61st Avenue is adjacent to residential driveways and is used for trash pick-up which obstructs a clear path for pedestrians.

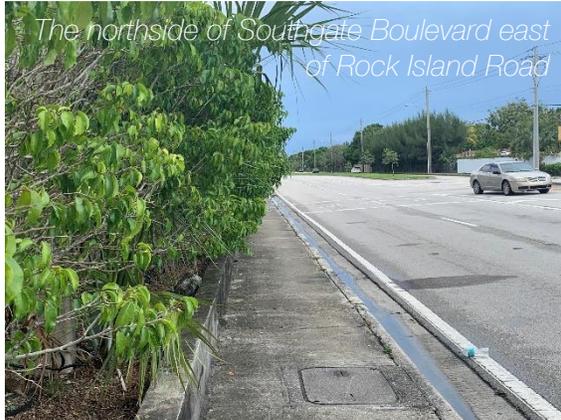
The northside of Southgate Boulevard east of Rock Island Road
Overgrown trees endanger pedestrians and block the view of pedestrian signs.

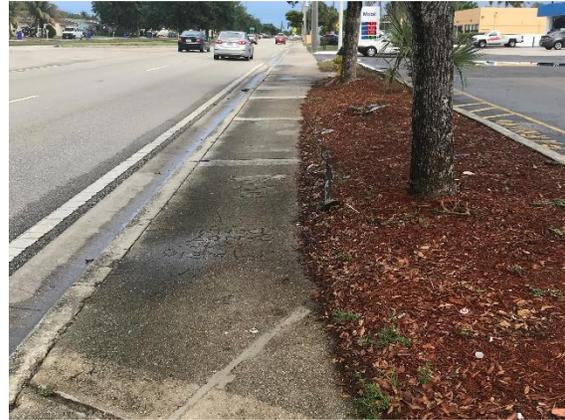
Unmaintained landscape encroaches the sidewalk facilities.

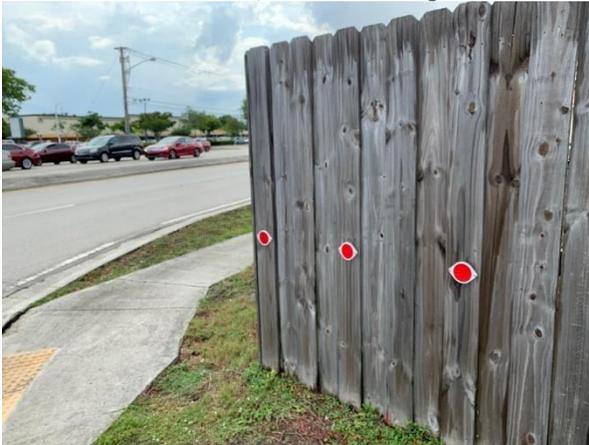
The wooded fences at the northwest corner of Southgate Boulevard and Rock Island Road may pose a visibility threat to motorists.

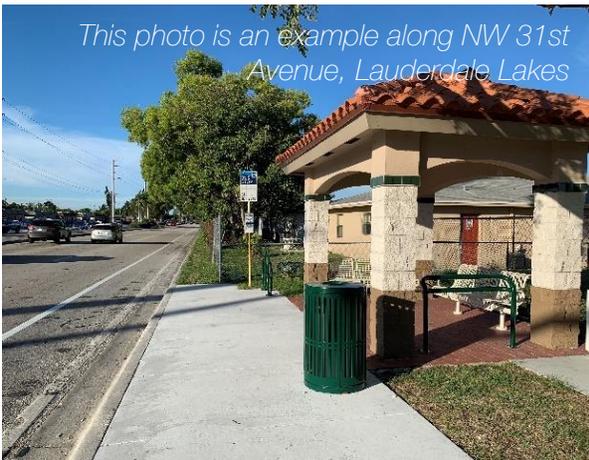
This photo is an example along NW 31st Avenue, Lauderdale Lakes

Provide a clear unobstructed 5'x8' landing pad and provide amenities such as bench, shelter, trash receptacle, bike racks, and a handrail at the Margate Inner-City Transit Route D stops.

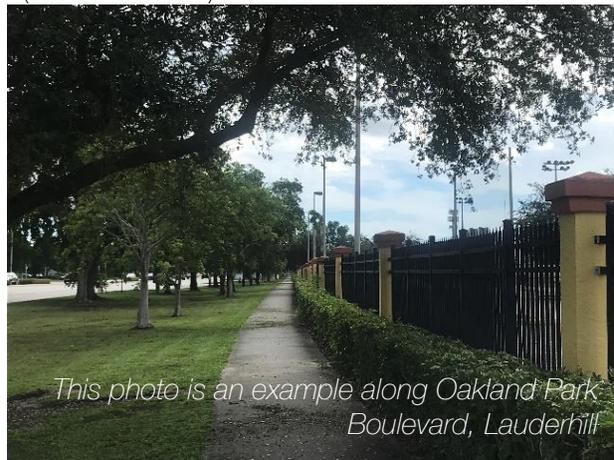
This photo is an example along Oakland Park Boulevard, Lauderdale Hill

Maintain the landscape throughout the corridor to prevent endangering pedestrians and blocking the view of pedestrian signs.
