Walking Audit Report

City of Deerfield Beach

Dixie Highway
from SR 834/Sample Road to
Broward/Palm Beach County Line

April 2019

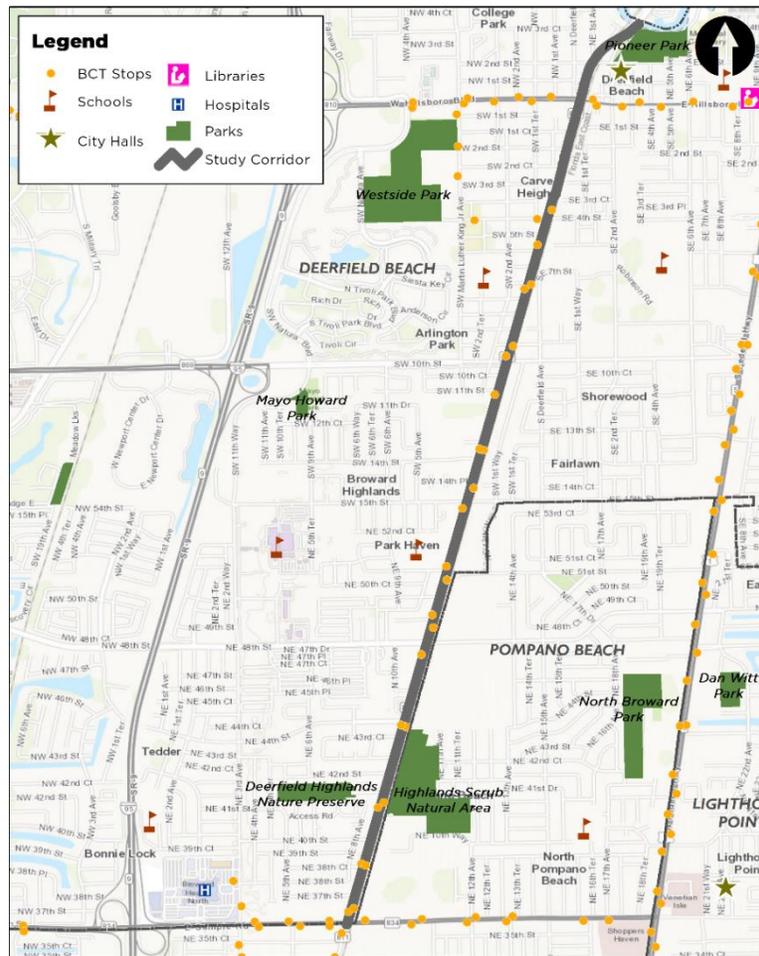
Figure 3. Study Corridor

Dixie Highway from Sample Road to Broward/Palm Beach County Line was selected as the study corridor for the walking audit by the MPO. The Complete Streets Master Plan ranked the corridor as 13 out of 152. The proposed recommendations for the 3.4-mile section of Dixie Highway includes a filled in pedestrian zone due to the sidewalk gap on the east side from Sample Road to SW 15th Street/NE 54th Street, furnishing zone, and buffered bicycle lanes. The study corridor is located in the City of Deerfield Beach and City of Pompano Beach as shown in Figure 3. Dixie Highway is a State Road, SR 811. The Broward MPO partnered up with the City of Deerfield Beach to host the Walking Audit community-based event on Saturday, November 3, 2018.

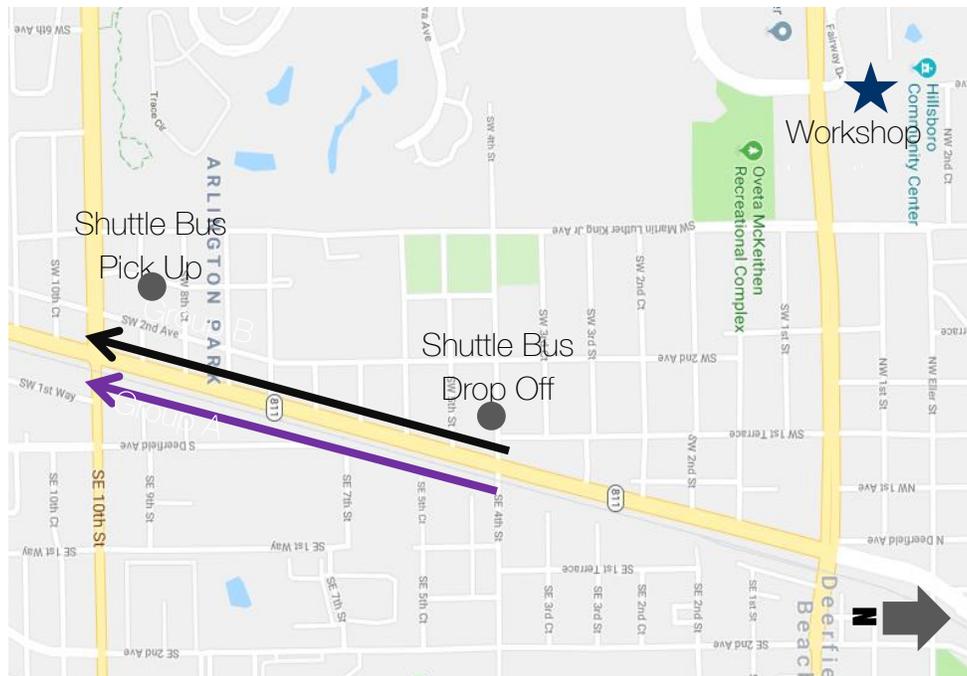
Figure 4. Walking Audit Route 1 – Group A and Group B

Figure 4 displays Route 1, Dixie Highway from SE 10th Street to SE 4th Street. Participants took a shuttle bus from Hillsboro Community Center to St Mary's Episcopal Church located at the southwest corner of Dixie Highway and SW 4th Street. Group A (purple polyline) walked on the east side of Dixie Highway and Group B (black polyline) walked on the west side. The shuttle bus picked up participants at an empty lot on the northwest corner of Dixie Highway and SE 10th Street and brought them back to Hillsboro Community Center. The total length of Route 1 is 0.5 miles.

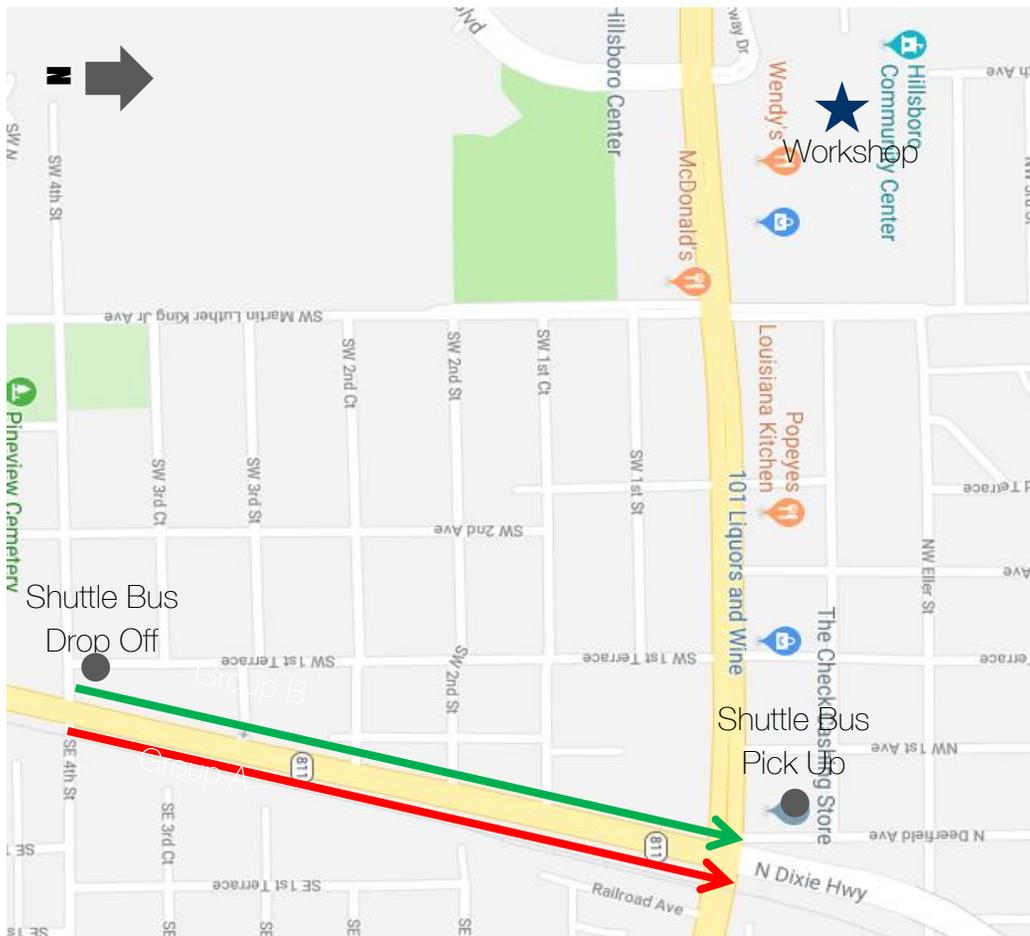
Figure 6. Walking Audit Route 2 – Group A and Group B

Figure 6 displays Route 2, Dixie Highway from SE 4th Street to SE 10th Street. Participants took a shuttle bus from Hillsboro Community Center to St Mary's Episcopal Church located at the southwest corner of Dixie Highway and SW 4th Street. Group A (red polyline) walked on the east side of Oakland Park Boulevard and Group B (green polyline) walked on the west side. The shuttle bus picked up participants at the strip-mall parking lot located on the northwest side of Dixie Highway and Hillsboro Boulevard and brought them back to Hillsboro Community Center. The total length of Route 2 is 0.5 miles.

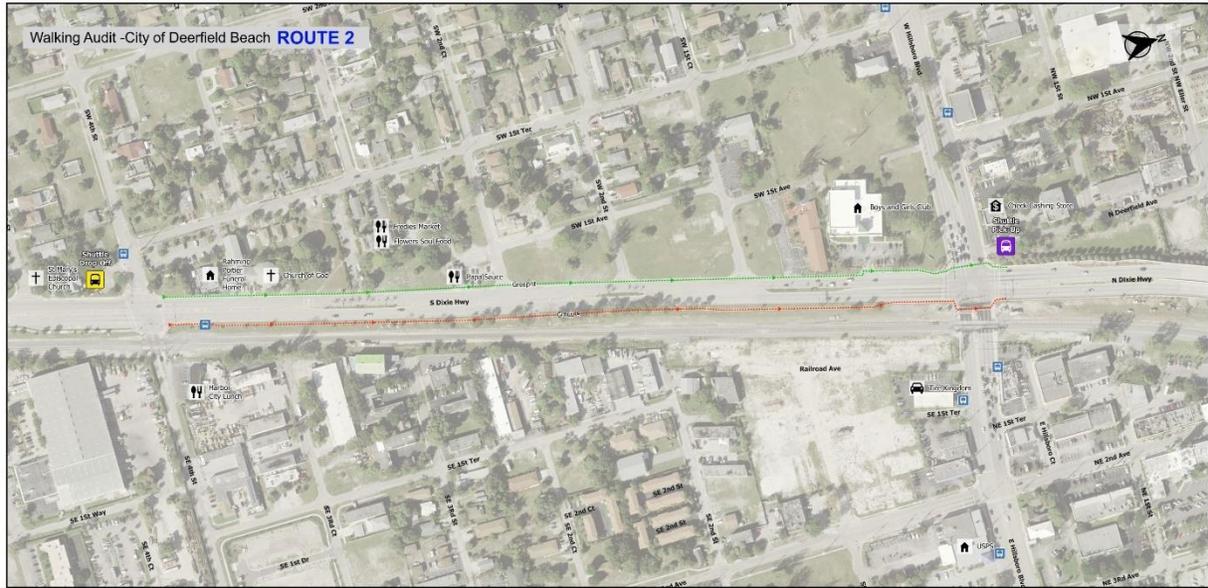
Figure 7. Walking Audit Route 2 – destinations

Shown in Figure 7 are the different destinations along Route 2. The FEC is on the eastern side of Dixie Highway. On the western side of Dixie Highway includes religious institutions, residential

properties, vacant parcels, restaurants and the Boys and Girls Club. Appendix A displays the different destinations along Route 2.

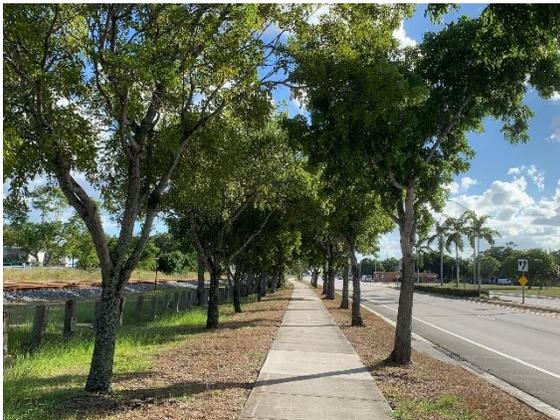
There is a sidewalk on the east side with a buffer between the sidewalk and curb, also known as a furnishing zone. In certain areas along the corridor the furnishing zone includes trees.

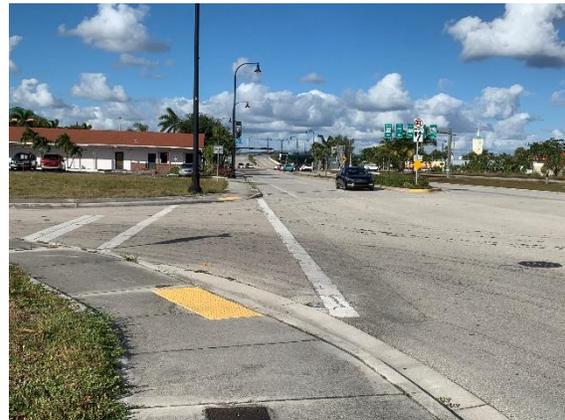
Street and pedestrian lighting exist along parts of the corridor.

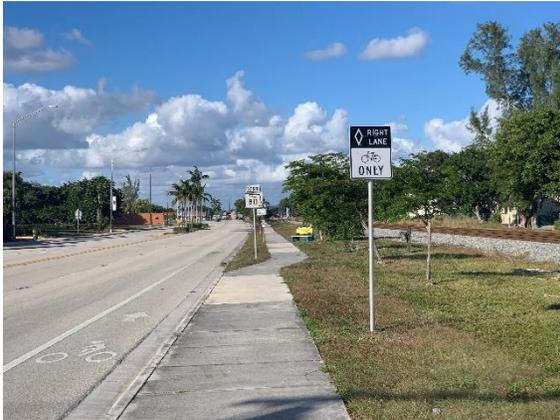
There are conventional bike lanes along the corridor with pavement markings and signage.

- Replace old signage that references “RIGHT LANE BIKE ONLY” and replace it with the current version of R3-17 (Bike Lane).
- Maintain the landscape to restore the green color and prevent grass from turning brown.
- Upgrade the pedestrian signals to countdown, the pedestrian push button signs to the current standard, and fix the functionality of the pedestrian push buttons at SR 811/Dixie Highway and SW 4th Street.
- Maintain signs and sign support such as on SR 811/Dixie Highway near SW 4th Street.
- Add trash/recycling receptacles, bike racks, and benches at BCT stops.

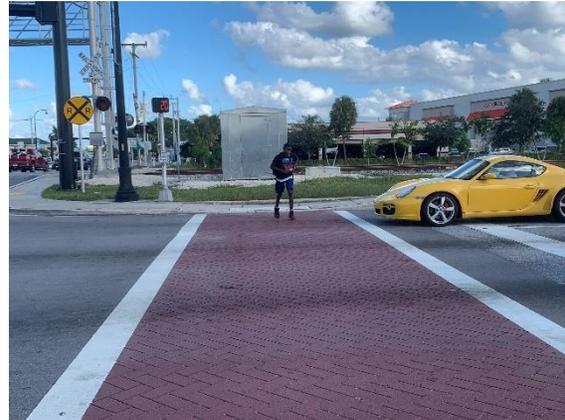
Stamped paver crosswalk at SR 811/Dixie Highway and SR 810/Hillsboro Boulevard.

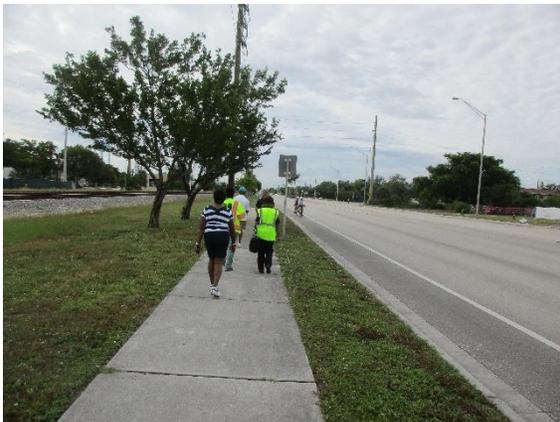
Two bicyclists riding northbound in the bike lane.

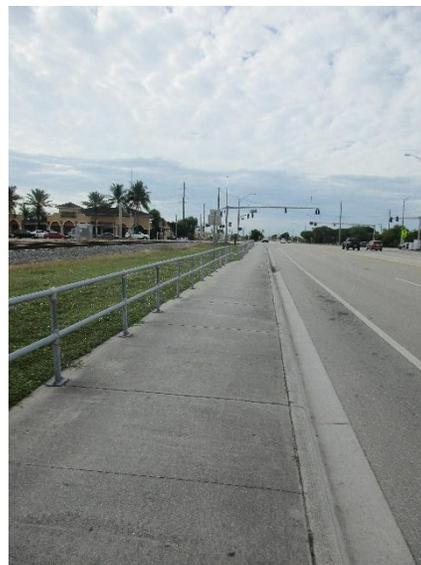
Short segment of pedestrian railing from SE 10th Street to SE 9th Street on the east side.

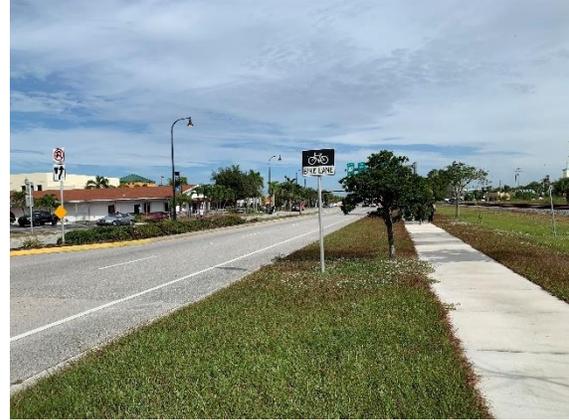
Replace old signage that references "RIGHT LANE BIKE ONLY" and replace it with the current R3-17 (Bike Lane) as shown above.

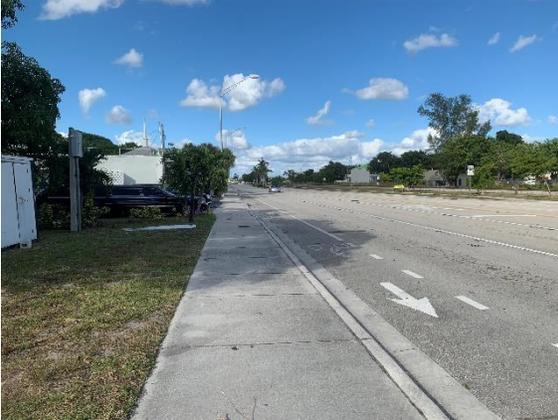
Lack of furnishing zone to provide a buffer between non-motorized users and motor vehicles on the western side, as well as potentially add trees to provide shade.

Provide a furnishing zone with street trees to add shade on the west side.

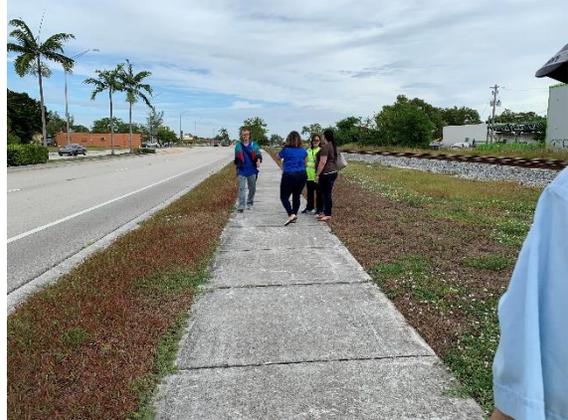
The grass appears to be brown and dying, which does not give a welcoming sense.

Maintain the landscape to prevent grass turning brown.

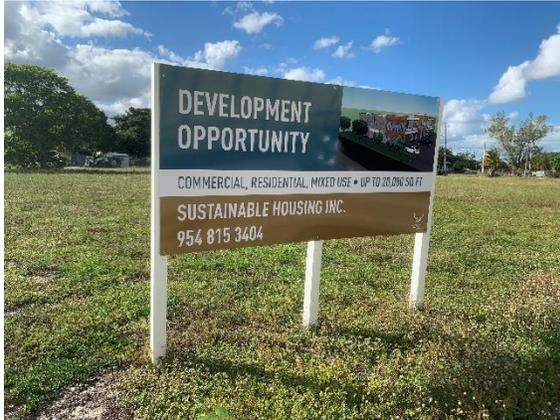
There are multiple vacant parcels for potential development opportunity. The potential development can enhance walking and bicycling infrastructure due to the Comprehensive Plan.

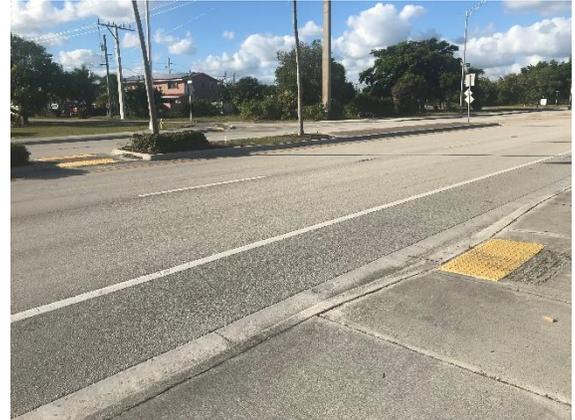
Further study is needed in providing a mid-block signed and marked crosswalk between SW 7th Court and SW 7th Street since the curb ramps and truncated domes are already in place. Residents reported that children cross near here unsupervised to get to Deerfield Beach Middle School.

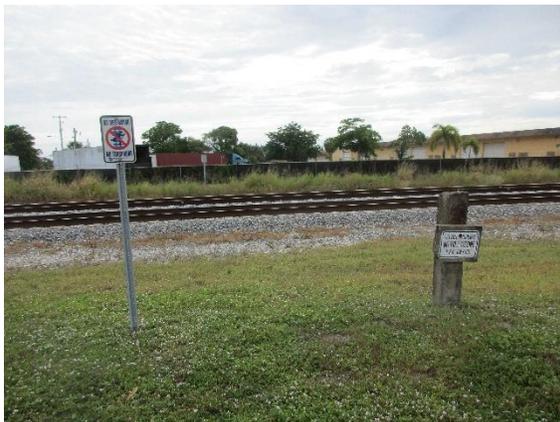
Existing "PRIVATE PROPERTY NO TRESPASSING F.E.C. RWY. CO" and "NO TRESPASSING" signage. The existing signage raises awareness to prohibit walking or playing on railroad tracks or the right-of-way on either side of the tracks as trespassing. It should be noted the City of Deerfield Beach wishes to install a fence along the FEC corridor as current situation does not stop people crossing the tracks.

- The City of Deerfield Beach wishes to install a fence along the FEC corridor as current situation does not stop people crossing the tracks. There are existing "PRIVATE PROPERTY NO TRESPASSING F.E.C. RWY. CO" and "NO TRESPASSING" signage.

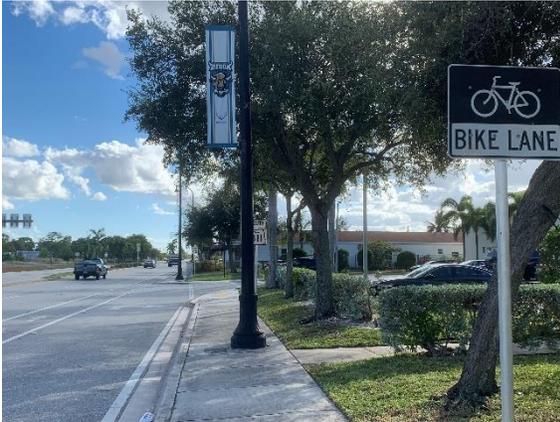
Street fixtures are within the sidewalk.

Provide an unobstructed pedestrian zone to prevent fixtures blocking non-motorized users.

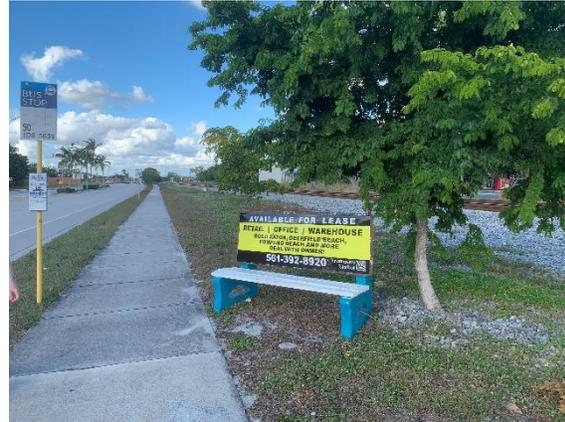
Route 50 – Stop ID# 5639 does not have ADA-compliant landing pad or shelter.

Provide a clear unobstructed 5'x8' ADA landing pad and provide shelters at BCT stops like NW 31st Avenue, Lauderdale Lakes.

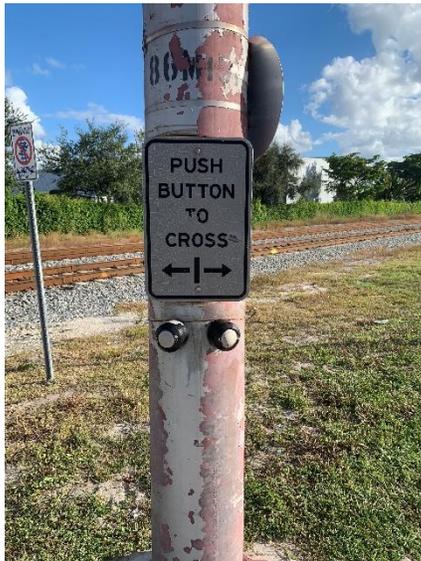
SR 811/Dixie Highway and SW 4th Street pedestrian push buttons in the southeast corner did not function.

Upgrade the pedestrian signals to countdown and the pedestrian push buttons at SR 811/Dixie Highway and SW 4th Street similar to the example above.

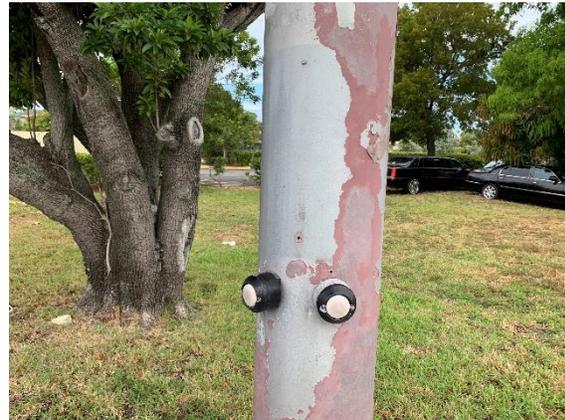
SR 811/Dixie Highway and SW 4th Street is missing signage on the pedestrian push buttons in the northwest corner.

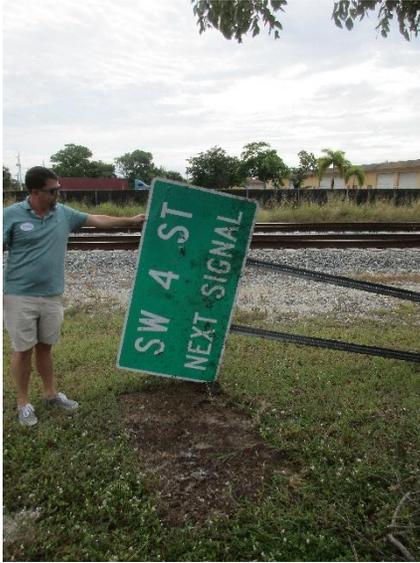
Signage knocked down.

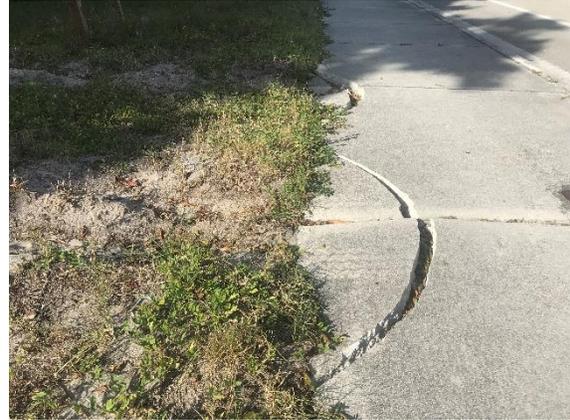
Concrete sidewalk cracking which causes trip hazards.

Evaluate the sidewalk condition to ensure a cross slope of 1% (2% maximum) to meet ADA standards.

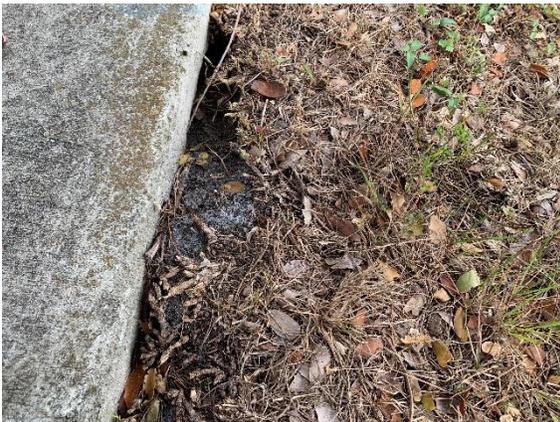
Soil wash out/erosion of subbase underneath concrete sidewalk.

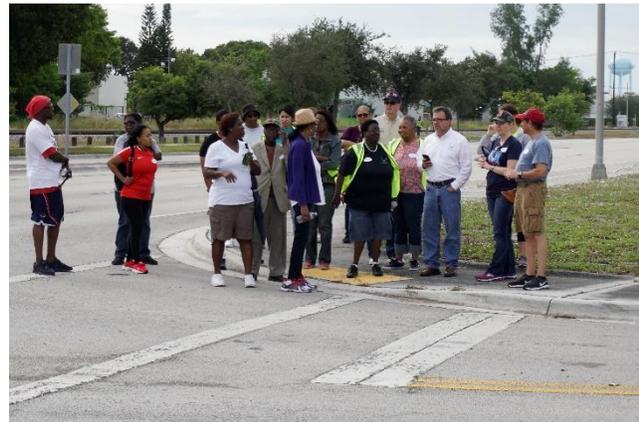
The width of the corner radii results in a longer crossing distance for pedestrians and allows for higher speed turns.

- Narrow the curb radii at unsignalized minor street intersections, such as on Dixie Highway and SW 1st Court, to reduce the risk for high-speed collisions with pedestrians. Typically, a 15' radius is appropriate for vehicle operation at a minor street intersection while balancing the needs of pedestrians.
